# BELZONA KEEPS THE LIGHT RAIL ON TRACK

ID: 5930

Steel train track for the city light rail transportation system.

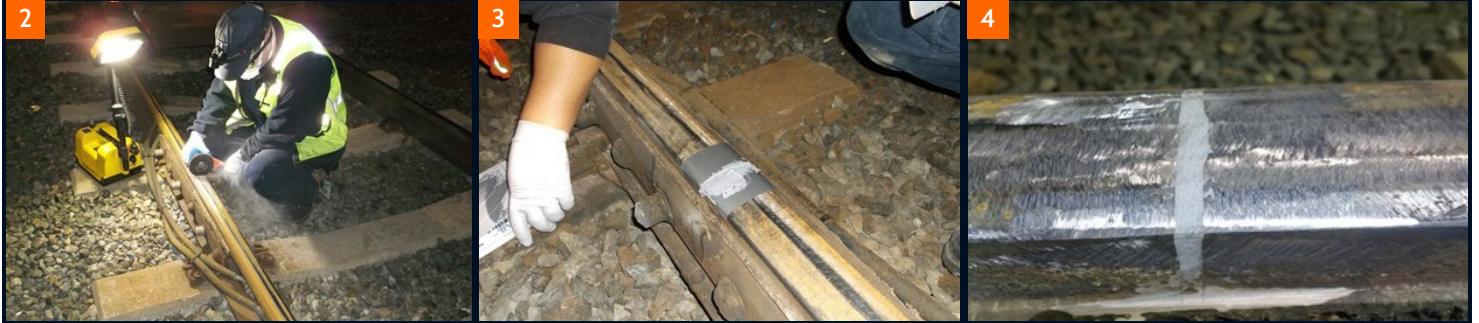
The fiberglass joint spacer was breaking down and the top of the track was weakening and getting pushed into the void.

1. Light Rail Joint; note the stress crack on the bottom-center of the joint
2. Grinding to remove the fiberglass and prepare the surface
3. Application of Belzona 1221
4. Completed application

A cutting wheel was used to remove the damaged fiberglass piece and then a grinding wheel was used to roughen and prepare the two surfaces. Duct tape was applied on either side of the repair for fast and easy clean up. An appropriate amount of Belzona 1221 was mixed and first worked into the two faces of the track. Then, the material was pushed in from the top until excess squeezed out on both sides. The excess material was scraped off, leaving it a little proud. A grinder was then used to machine it down to the proper profile.
