# CENTRIFUGAL PUMP REPAIRED AT A FRACTION OF THE COST OF REPLACEMENT

ID: 6034

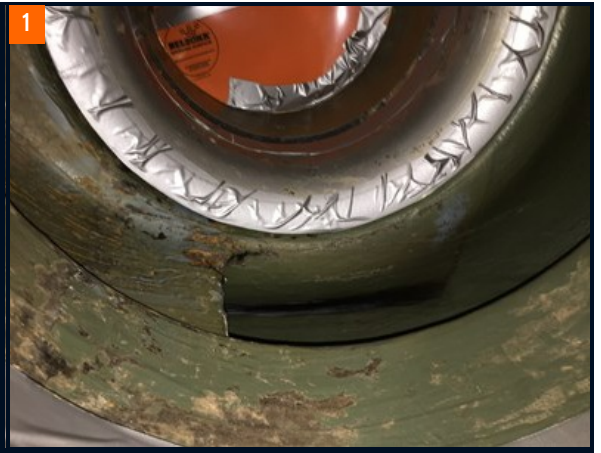
Badly damaged pump casing internals with pitting could not be removed and replaced or put back in service.

1. Corroded and damaged pump before application.
2. Pump casing coated with Belzona 1331.
3. Pump casing seven months after the application. This time instead of coating or replacing, the plant inspected and returned to service with little to no down time.
