# BELZONA PRESERVES 60-YEAR-OLD WATER PUMP FOR IRRIGATION DISTRICT

ID: 6037

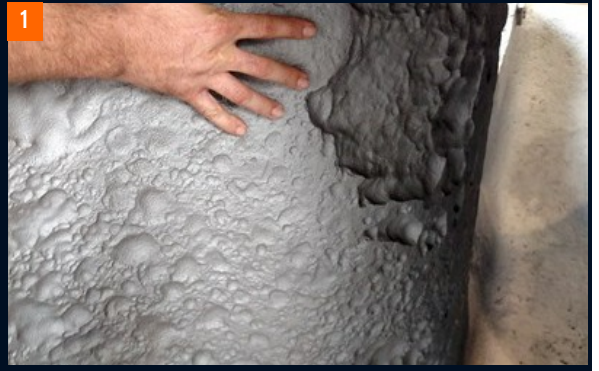
Flanges on the split line, wear ring fits, and packing areas were severely corroded, preventing the pump from sealing and made it very inefficient.

1. Severe corrosion in body of the pump
2. Close up of screws installed
3. Screws installed in split line and wear rings
4. Completed application to pump case

The application was carried out in accordance with modified versions of Belzona Know-How System Leaflets CEP-3 and CEP-5. Because of the severe erosion/corrosion damage of the wear ring fits and split line, 2"+ thickness of Belzona 1111 was needed. Because of this, self tapping screws/bolts were installed to provide stability to Belzona 1111. After 1111 was installed, all fits were machined. Belzona 1341 was coated on all wetted surfaces.
