# BELZONA REFURBISHES TRAIN DIESEL TANK

ID: 6066

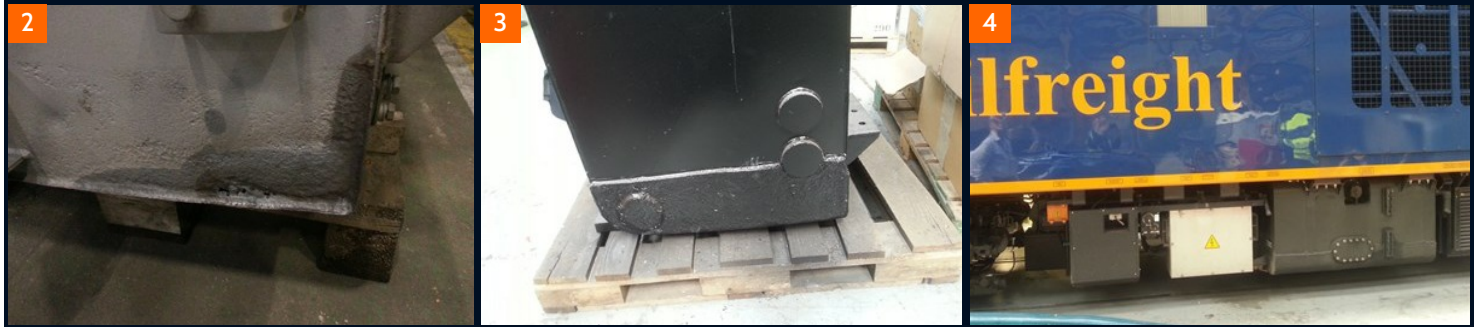
Moisture was entering the gap between the steel tank and the fibreglass coating, resulting in corrosion damage and leading to pitting and holes.

1. The corroded diesel tank before treatment
2. Lower portion of the tank prior to treatment
3. Tank plate-bonded with Belzona 1121 and coated in GRP
4. Repaired tank refitted to train

Application was carried out in accordance with Belzona Know-How System Leaflet TCC-1. The fibreglass coating was grit blasted away. Metal plates were then cold bonded over the defects using Belzona 1121 and the tank then re-coated with GRP, painted black and refitted onto the trains.
