# IMPELLED TO ACTION

ID: 6070

Cavitation had caused damage to a number of locations on the impeller blade of a Swedish hydropower plant. The damage reduced plant efficiency, and if untreated could ultimately have led to total mechanical failure.

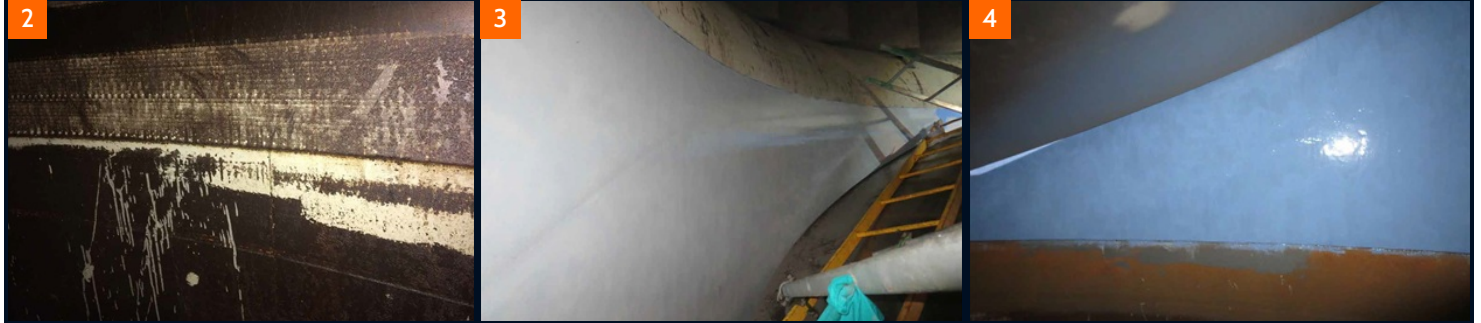
Impeller blade suffering from serious cavitation damage in approximately 15 places.

1. Damage to the impeller
2. Scratch damage and wearing
3. Belzona 1311 Ceramic R-Metal topped with Belzona 1341
4. Second and final coat of Belzona 1341

The affected area was brush-blasted to provide a suitable substrate surface. One layer of Belzona 1311 was then applied and left to cure, followed by two successive layers of Belzona 1341.
