# BELZONA CASTING IMPERFECTION REPAIR

ID: 613

Cast pump casing

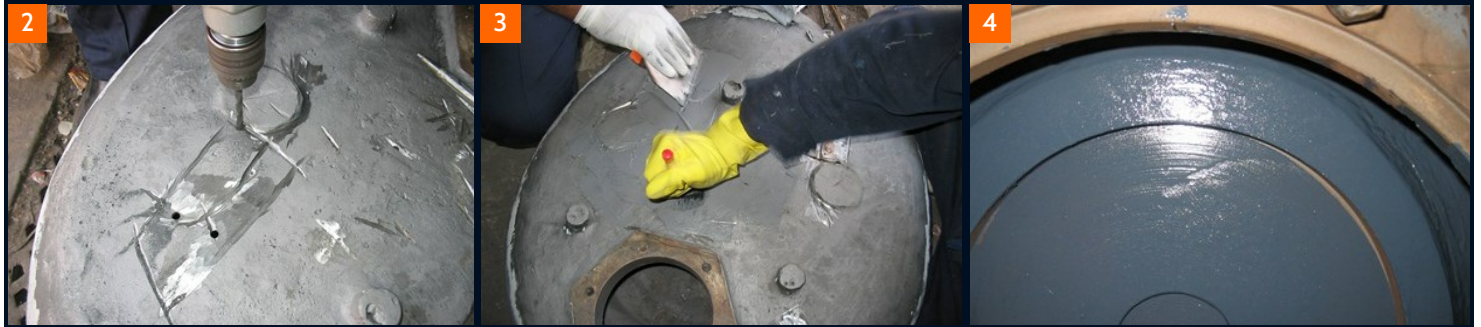
Defects in casting caused holes and cracks in the pump.

1. Casting imperfections in the pump
2. Preparing the cracks in the pump
3. Wetting out the surface with Belzona 1311
4. Pump was repaired and protected

Application was carried out in accordance with Belzona Know-How System Leaflet CEP-3 and CEP-6.

Instead of recasting the pump which would take too long and be very expensive, Belzona easily repaired the casting imperfections and also provided protection to the pump.
