# PRESS ROLL CRACK REPAIR WITH BELZONA

ID: 616

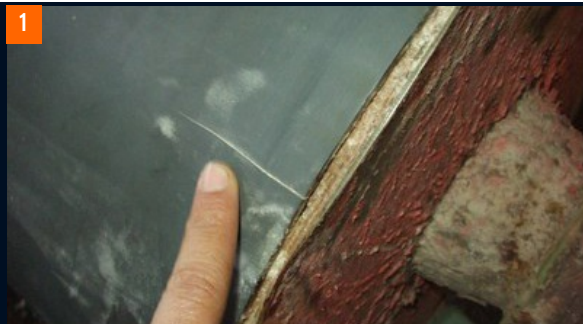
Crack in the hard rubber cover of the press roll. The crack was increasing over time.

1. The crack in the rubber cover
2. Removing the cracked layer
3. Belzona 1111 applied to the roll
4. Completed repair
