# BELZONA SEALS BROKEN SKYLIGHTS

ID: 6297

Office building, Bielsko-Biala, Poland

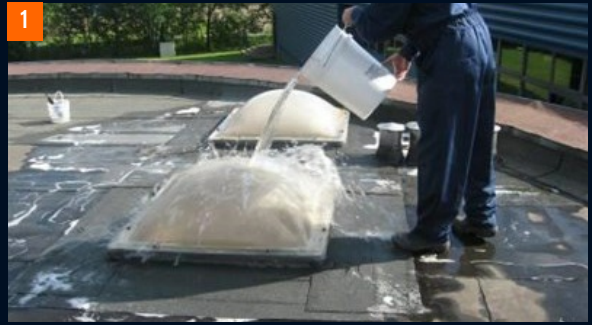
Under the influence of the sun skylights had broken around the fastening bolts allowing leakage of water into the rooms below whenever it rained.

1. Washing damaged skylights 2. Application of Belzona 3111 onto the Belzona 3911 Conditioner 3. Rooftop view immediately after the repair. 4. Rooftop view August 2016

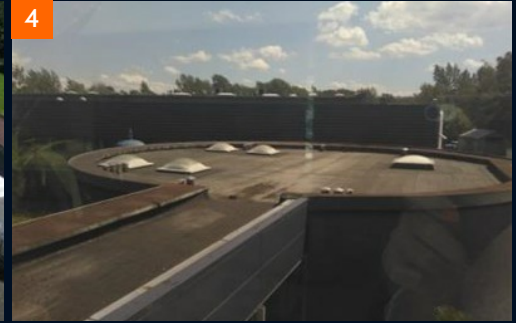
Repair cost less than half the purchase and replacement costs of new skylights. Inspected in August 2016 repairs still in excellent condition and keeping offices dry.
