# BELZONA REPAIRS A SEPARATOR AND SAVES OIL PRODUCTION

ID: 6375

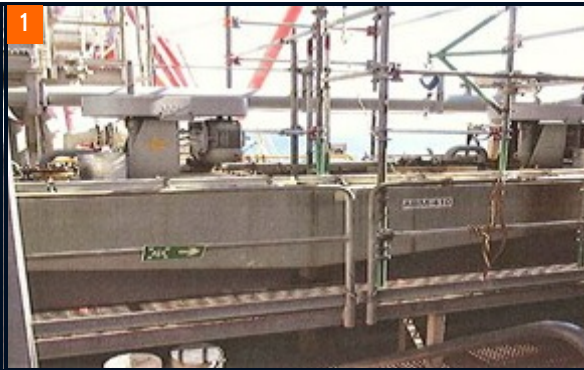
1. Overall view of separator
2. View of hole in floor.
3. Hole repaired by cold plate bonding and begin top coating.

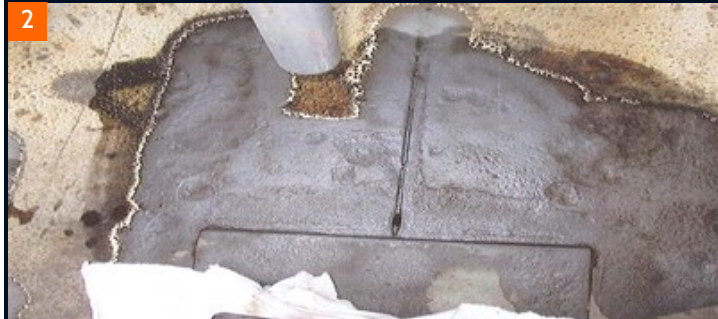
A Wemco oil/water/gas separator used for cleaning water was suffering from a through wall defect. The customer required this vessel to be operational again. Bypassing the unit was not allowed and without the functioning separator the platform could not run production of oil.
