# BELZONA SAVES CAST IMPELLER FROM SCRAP

ID: 6423

New cast iron impeller slurry pump

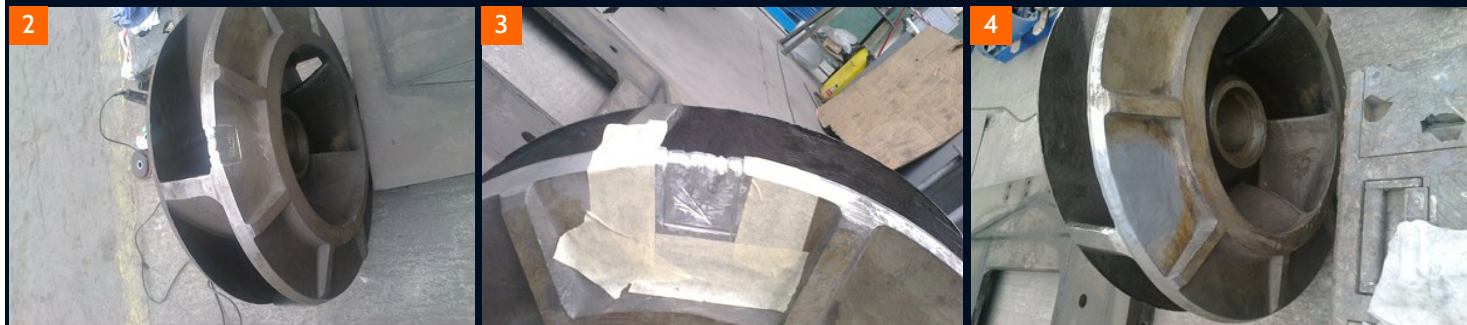
Set of cracks on one side of the newly cast impeller. The end-user had refused to accept the impeller without elimination of the cracked area. After mutual agreement between the customer and end-user, they agreed that a Belzona solution could be used.

1. Impeller before application
2. Mechanical grinding and machining of cracked area
3. Masking of the repair area
4. Completed application

Application was carried out in accordance with Belzona Know-How System Leaflet CEP-6. All cracks were terminated, then Belzona 1311 was applied on the cracked area with reinforcement tape. More Belzona 1311 were added to restore the original profile of the impeller and give a smooth finish.
