# BELZONA REBUILDS SHAFT DURING WIND TURBINE MAINTENANCE

ID: 6437

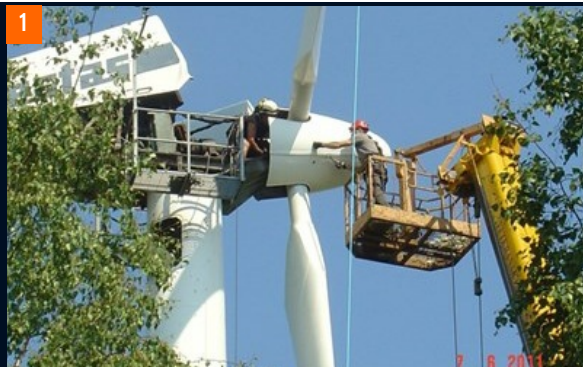
1. Crane access required to maintain the nacelle
2. Nacelle removed for routine inspection and maintenance
3. Corroded shaft
4. Shaft rebuilt using self-lubricating Belzona 1131

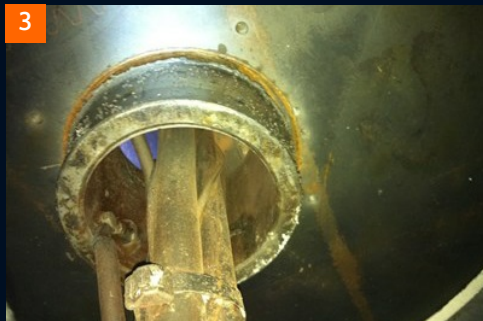
Inspection revealed that the nacelle had suffered from water ingress and the yaw drive shaft was experiencing damage due to corrosion and wear due to lack of lubrication.

Application was carried out in accordance with Belzona System Leaflet MPT-2. A former was used to mould Belzona 1131 to correct dimensions.

Belzona 1131 possesses self-lubricating properties for creation of low friction surfaces in the event of lubrication loss. The product is also corrosion resistant. This made it the ideal solution for the shaft repair. This application is still in service as of 2017.
