# BELZONA REPAIRS SHIPS GENERATOR AFTER WELD REPAIR FAILS

ID: 651

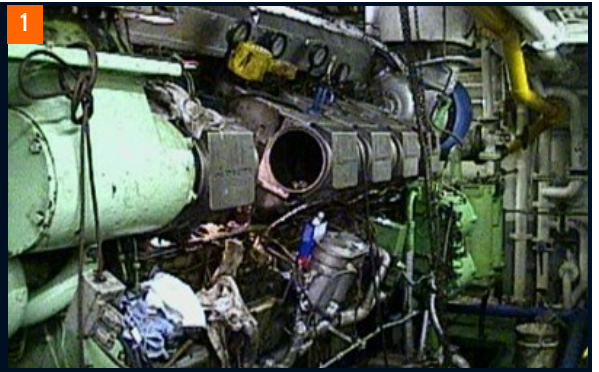
Damaged generator casing allowing coolant into main sump threatening ships main engine bearings.

1. Generator with cylinder removed
2. Surface surrounding failed weld roughened
3. Belzona 1111/9341 patch applied over weld repair and extended onto surrounding area
4. Final repair smoothed out and awaiting Infrared lamp to accelerate cure

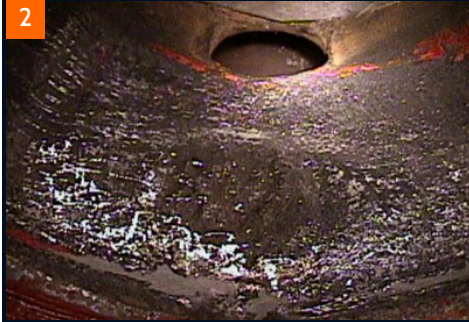
Main generator oil sump which is shared with ships main engine. Initial weld repair failed.

Classic failure of welding cast iron. Ship sails nightly but re-work completed in 5 hours keeping ship on schedule at full power. Customer is delighted with Belzona!

Application carried out in accordance with Belzona Know-How System Leaflet ENC-1. Particular attention paid to removing all substrate contamination using solvent washing and heat.
