# BELZONA REPAIRED DAMAGED MIXER AGITATOR DRIVESHAFT AND KEYWAYS

ID: 659

Mixer agitator driveshaft and keyways

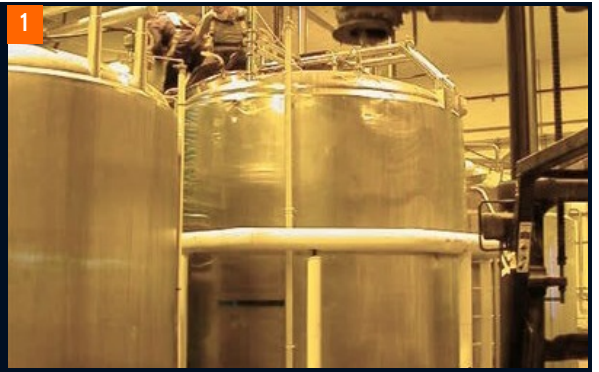
1. Mixing tank
2. Damaged drive shaft
3. Agitator socket
4. Ready for assembly

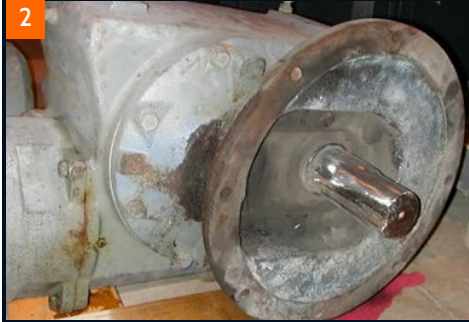
Acid damaged shaft lost 1/2" on the diameter, keyway and key were destroyed. Socket keyway was minimally damaged, but needed to be tightened up. Obsolete drive was built in 1965 and the MFG has been sold twice. Therefore, no parts or prints are available. Mixer shut down. It was imperative that it would be operated in only two days.

The application was carried out according to the modified version of Belzona Know-How leaflet system MPT-2. Belzona 1111 was used to build up the shaft diameter and also applied inside the socket and around the new key to fill the keyways. While still wet, the shaft was carefully dropped into the agitator socket keeping the key tight in both keyways.
