# BELZONA REPAIR TO LARGE EXCAVATOR CONTROL CABLE

ID: 662

Control cable from large iron ore excavator.

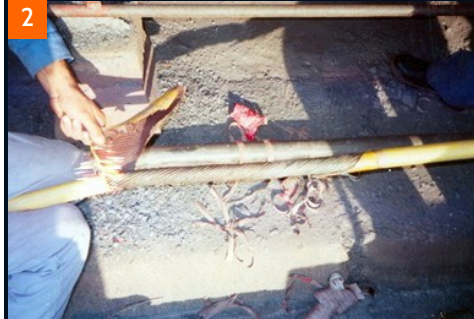
1. View of excavator
2. Torn cable cover
3. Repaired cable with Belzona 2311
4. Condition after 14 months in service

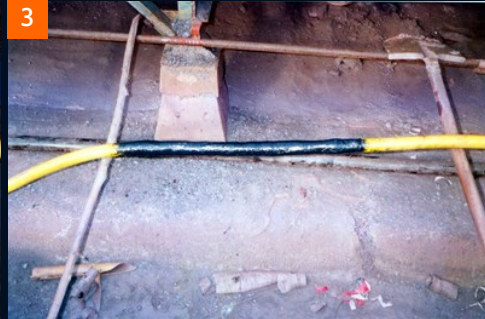
Torn cable cover due to weather influences and friction with ground. There was need for material which is elastic, has good adhesion, abrasion and water resistance.
