# BELZONA RENEWS DEFORMED CONVEYOR DRIVE DRUM

ID: 663

Rubber clad conveyor drive drum.

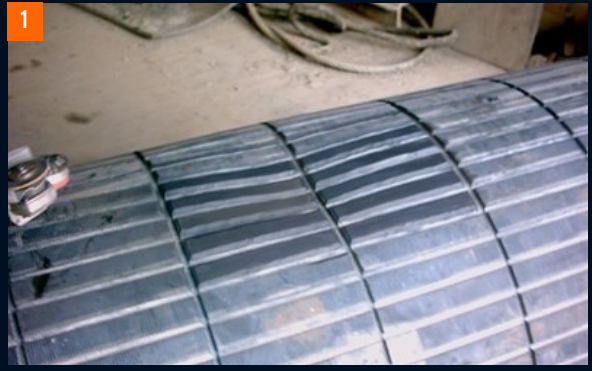
The drive drum had a 15 mm rubber cover. The surface of the drum was mechanically deformed during transportation with fork lift truck.

View of the damaged drum Preparing the deformed area Finished application

Application was carried out in accordance with Belzona Know-How System Leaflet SHM-9.
