# BELZONA KEEPS COOLING WATER PUMP RUNNING

ID: 664

## PROBLEM

Cavitation-erosion damage on the impellers

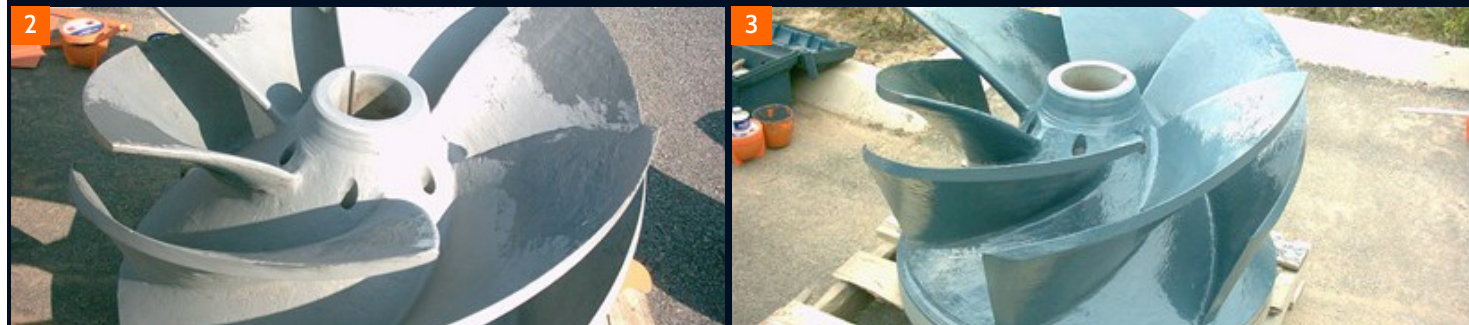
## PHOTOS

Cavitation reduces thickness of the blades, increasing risk of their breaking. Belzona® 1311 rebuild restored impellor profiles. After applying of Belzona® 1321, the power consumption decreased and the flow increased. Replacing the pump costs about 50.000,00 EUR and it takes 60 days. This application had been done twice on two impellers.

1. Eroded pump blades
2. Filled pump blades with Belzona 1311
3. Finishing with Belzona 1321

Application was carried out in accordance with Belzona Know-How System Leaflets CEP-5 and CEP-7.
