# BELZONA KEEPS WHEAT REFINER RUNNING

ID: 665

Drive shaft on Wheat refiner

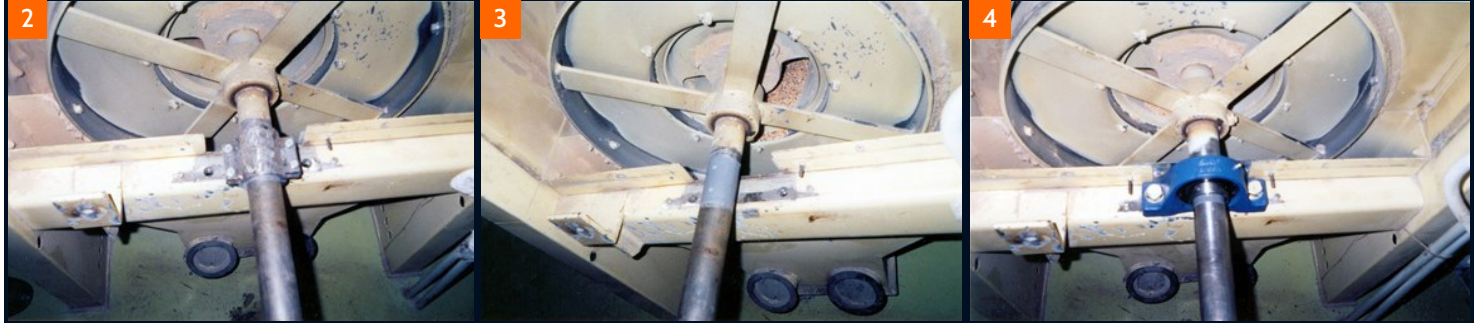
Bearing failure damaged the shaft.

1. The damage on the shaft is evident
2. The former was used to rebuild the shaft
3. The former was removed after Belzona 1221 had cured
4. Bearing re-assembled

Application was carried out in accordance with Belzona Know-How System Leaflet MPT-2. Two part mold was prepared before-hand to restore correct shaft diameter.

The application was done in few hours. Conventional welding method could cause deformation. Delivery time of a new shaft was 4-6 weeks. New shaft costs 3,700 EUR. All work was finished for 150 EUR. This application was done twice. The shaft still running today.
