# BELZONA SCRUBBER HEADER PATCHED

ID: 67

Fiberglass header in scrubber unit

Power Plant in North Texas

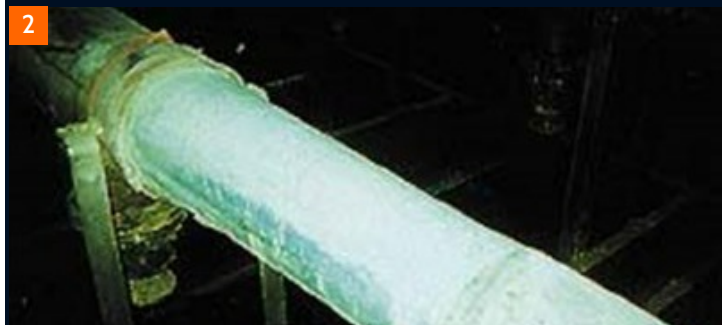
Scrubber nozzles spray lime slurry to neutralize flue gas. Nozzle gets plugged or worn, redirecting a side stream that tears holes in fiberglass headers.

1. A view in the plant
2. Fiberglass header in scrubber unit
3. Header patched with Belzona 1811
