# BELZONA REBUILDS THE UNDERSIDE OF PULPMILL FLOOR

ID: 685

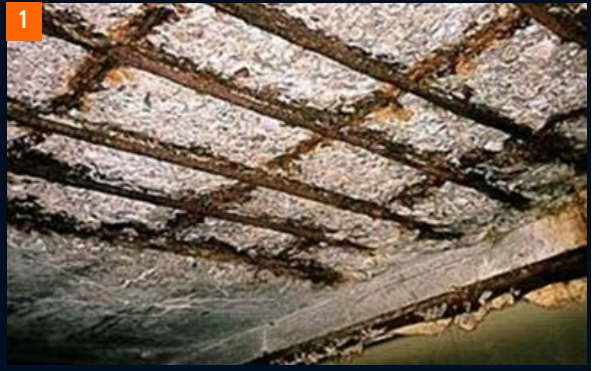
Moisture, vibration and impact from above had caused the underside of this concrete deck to spall badly leaving exposed corroding rebar.

1. View of corroded rebar and spalled concrete underside
2. A partially completed underside showing the unfinished section after grit blasting to remove all corrosion from the rebar
3. Application in final stages of completion

Using Belzona 4141 Magma Build allowed the underside of the floor to be rebuilt in a single application without the need for forms saving many additional hours of downtime when compared with a conventional repair (Footnote: The damaged sections on the top side of the deck were rebuilt in 2002 with Belzona 4111 Magma Quartz and the complete deck area sealed with Belzona 5122 (Clear Cladding).
