# BELZONA SOLVES COAL POWER PLANT ASH PIPE PROBLEM

ID: 697

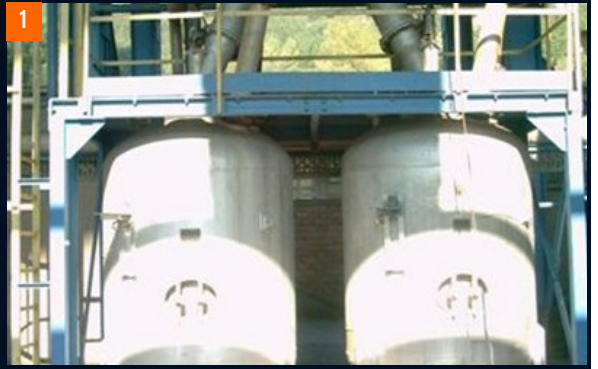
Holed pipe caused by coal ash containing a high percentage of quartz

1. Application situation
2. A traditional repair which had holed again
3. The Belzona repair

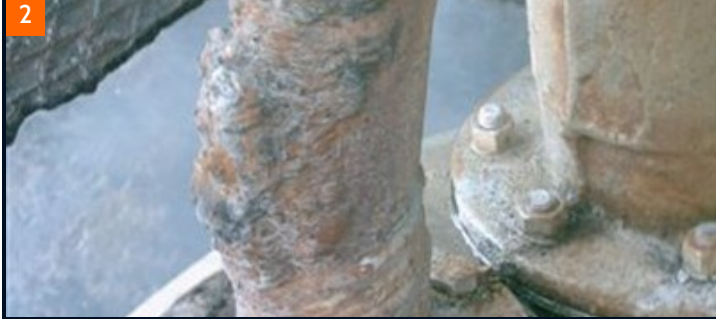
Every few weeks some of these pipes become holed and are traditionally welded. Welding these pipes is typically very difficult and after a very short time the problem reappears at the same point. After the application of the Belzona® solution at 30-40mm along with steel plates the problem stopped. By January 2006 there had been many of these repairs completed and none had become holed again.
