# BELZONA REPAIR OF RUBBER IMPELLER

ID: 744

Rubber covered pump impeller.

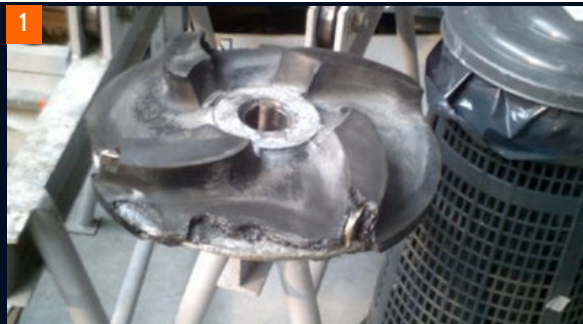
Whilst casing had little damage, the impeller vanes were very badly damaged and needed rebuilding.

1. The damaged impeller
2. Aluminum formers in place
3. Casting underway
4. The finished impeller
