# BELZONA 1212 SEALS PROPULSION SHAFT FLANGE

ID: 7466

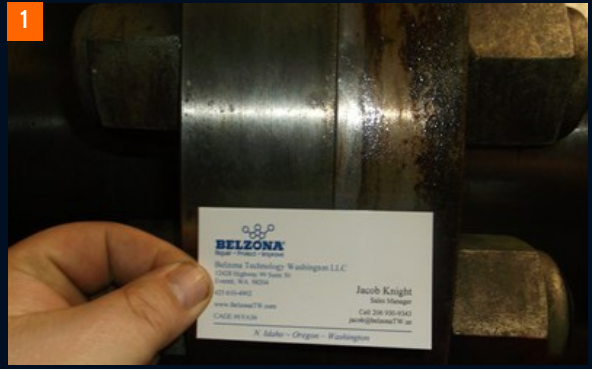
This flange is not designed to retain oil, but since there is a hose inside the propulsion shaft leaking oil, the need to seal off the flange to keep oil from being sprayed all over the engine compartment is very important for many reasons including personal safety. The second part of this problem is that the supply tank is over 40' above the shaft and cannot be shut off. This means the oil leak had to be stopped while under pressure.

Oil leaking from the flange when the propulsion shaft is spinning.

1. Showing the size of this oily flange.
2. First layer of Belzona 1212 with Belzona 9341.
3. Second coat of Belzona 1212.
4. Final application of Belzona 1212, all oil leaks stopped.

The repair was carried out following a modified version of Belzona Know-How System Leaflet VPF-11. A hand grinder was used to clean and prep the steel. Belzona 1212 was mixed and most of its working life allowed to pass prior to application in order to stop the oil leak.
