# BELZONA REPAIRS ALLOW OFFLOADING TO RESUME

ID: 7490

Low pressure steam turbine

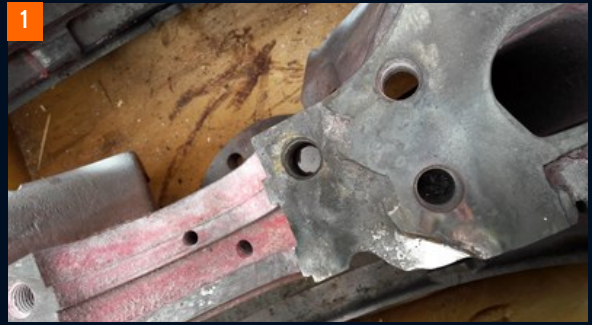
Corrosion and significant loss of metal on many areas of one half of the flange face.

1. Localised damage on the flange face
2. After surface preparation
3. Forming in-operation using the other half of the split casing
4. Finished result
