# BELZONA REPAIRS WIND TURBINE SHAFT IN PLACE

ID: 7502

Wind Turbine Shaft on Wind Farm

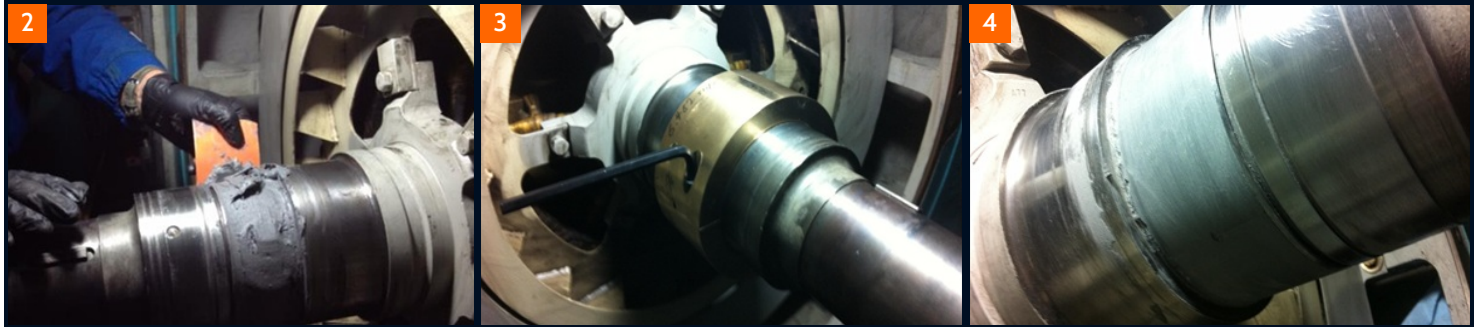
The shaft in this wind turbine at a wind farm was not grounded properly causing electrolysis damage. The damage was considerable and was destabilizing the turbine.

1. Shaft damage by electrolysis.
2. Shaft with Belzona 1111 being applied
3. Shaft with copper former while Belzona 1111 is curing. The release agent was applied on the former.
4. Former removed and the application is now completed.

The application was carried out in accordance with the Belzona System Leaflet FBC-13. A brass cast former was made to the exact dimensions of the shaft repair.
