# BELZONA REPAIRS A FLOATING HOSE

ID: 7511

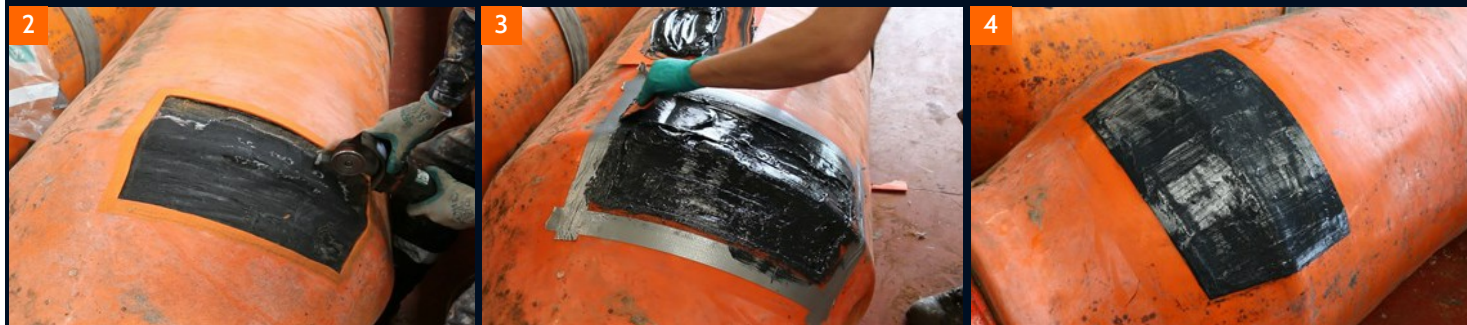
The rubber reinforced covers and flotation/insulation on fuel hoses was damaged. Thought to be caused by the ships propeller during fuel loading and unloading.

1. Damaged rubber.
2. Surface preparation.
3. Application in progress.
4. Finished application.

The repair was carried out in accordance with Belzona Know-How System Leaflet SOS-12.

Belzona 2211 (MP Hi-Build Elastomer)
