# BELZONA REPAIRS OIL LEAKS ON WIND FARM TRANSFORMER

ID: 7535

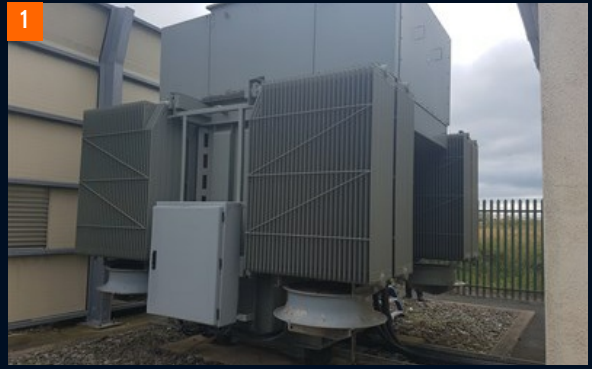
1. General view of the transformer
2. Leaking oil on the flange
3. Flange face filled with Belzona 1161 and caps installed
4. Completed section

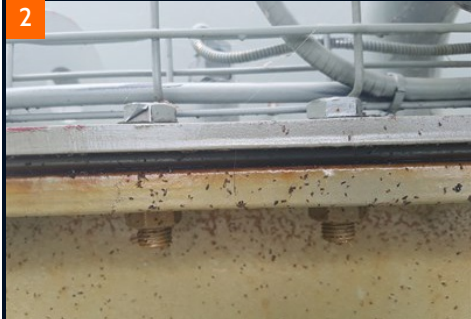
Transformer for a wind farm was leaking oil through the main flange and flange bolt holes. Approximately 120 bolts were leaking.
