# BELZONA PROTECTS PUMP IMPELLER FROM CAVITATION

ID: 7542

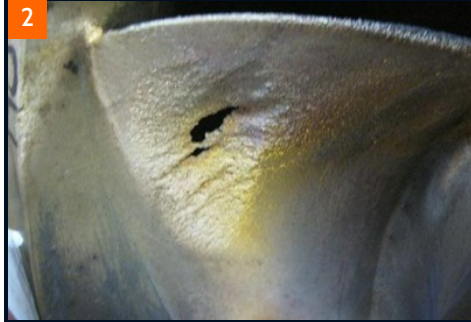
A pump impeller was found to be suffering heavily from cavitation whilst in service. Characteristic cavitation damage was found on the impeller vanes. The cause of the cavitation issue could not be eliminated from the pump.

1. Damage apparent over the impeller vanes
2. Close up of cavitating areas
3. Belzona coatings being applied
4. Finished application

The application was carried out in accordance with Belzona System Leaflets CEP-1 and CEP-3. The impeller was first grit blasted, then the damaged areas of the vanes were rebuilt using Belzona 1311. The impeller was then coated using Belzona 1341 and Belzona 2141 to protect from future damage.
