# BELZONA COMPLIANT SUPERWRAP REPAIR ON RISER WELLHEAD CASING

ID: 7558

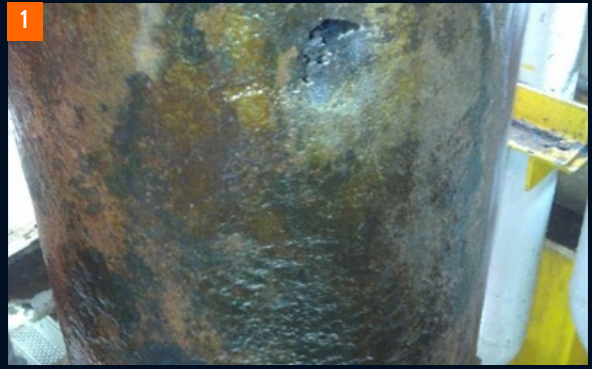
Severe corrosion on 17 years old 18" production riser on a North sea oil producing platform had resulted in a critical through wall defect. The riser was containing drillfluid as the oil production from the well been stopped recently. The drillfluid was leaking into the surrounding casing through the defect creating possible safety and environmental issues. The design parameters were: 20 years life expectancy, design temperature 55 deg Celcius and design pressure 1 MPa

1. View of defect area.
2. Gritblasting details.
3. Gritblasting details and defect area patched and prepared using Belzona 1111.
4. Completed SuperWrapII application.
