# RUBBER TRACK ON CRANE REPAIRED WITH BELZONA

ID: 756

In place repair of a rubber track on mobile crane.

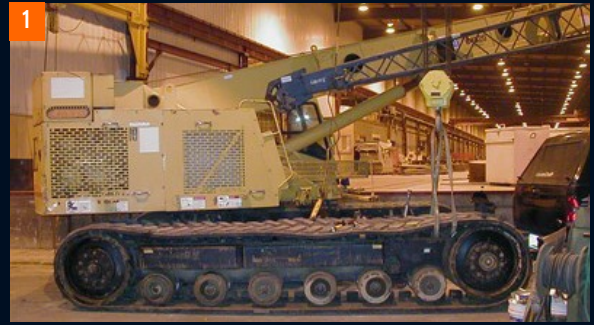
Track was ripped and would have to be replaced at a cost of \$7,000 without the repair.

1. Crane to be repaired
2. Prepared surface area ready to be repaired
3. Lifting strap used as reinforcement sheet
4. Completed bottom side of the application
