# BELZONA SUPERWRAP II REPAIRS 6" OPEN DRAIN SYSTEM

ID: 7562

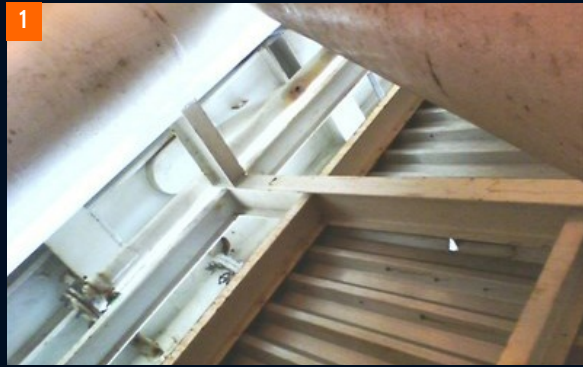
Internal corrosion caused multiple through-wall defects on the pipes.

1. The defective pipe
2. Pipe system following surface preparation
3. Completed application detail
4. Completed application
