# BELZONA REPAIRS DAMAGED TURBINE FLANGE FACE

ID: 7570

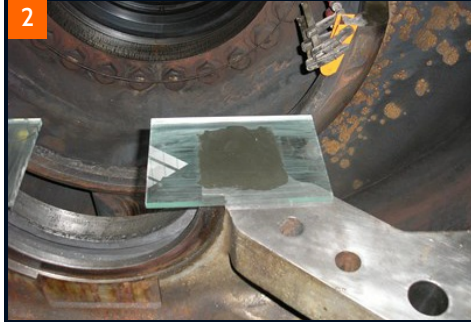
Wet steam caused erosion corrosion damage to flange face of turbine casing. This damage meant steam leakage from the turbine.

1. Damaged turbine split casing
2. Glass panel (coated with Belzona 9411 Release agent) used to form flat surface on Belzona
3. Repaired area
4. Turbine ready for mounting
