# LORRY ENGINE REPAIRED WITH BELZONA

ID: 7576

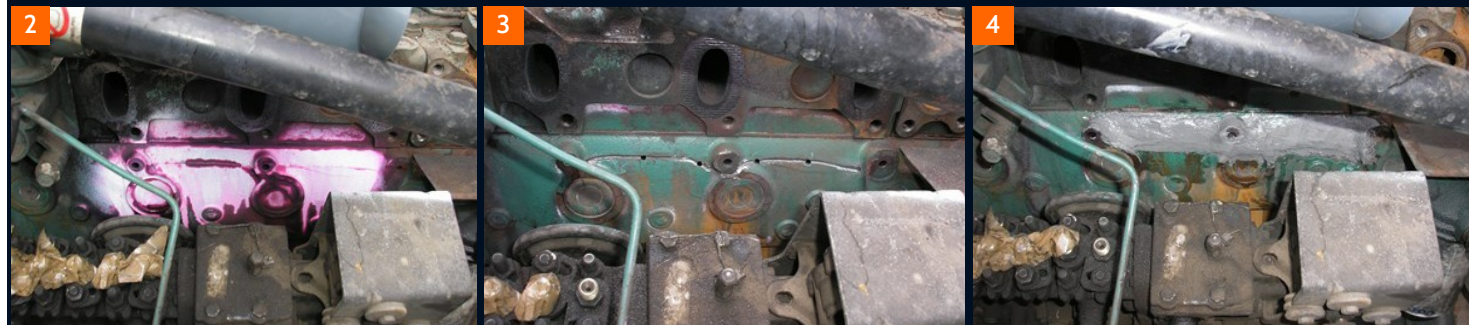
Cracked block due to freezing over winter months.

1. Cracked engine
2. Crack detection to identify all cracks
3. Surface preparation
4. Belzona 1111 repair incorporating Belzona 9341 Reinforcement Tape.

Welding of this damage would take a long time and potentially cause more damage so repairing with Belzona 1111 was much better for customer.
