# PUMP PROTECTION

ID: 7590

## PROBLEM

Erosion/ corrosion

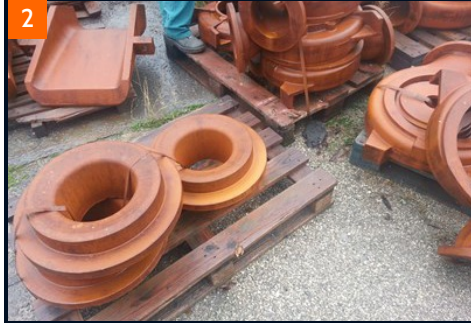
Size and quantity of solid parts in salt brine caused pump destruction.

Original coating protection - rubber was destroyed in short time. Combination of products Belzona 1812 and 1391 was good solution was this customer. Titanium pumps, which are able to work in these conditions, are very expensive.

1. Damaged internal surface of the pump.
2. The customer uses a large number of pumps in production.
3. The pump is ready for shipment to the customer.
4. Repair detail with Belzona 1812 and 1391 products

Belzona 1812  
Belzona 1391
