# BELZONA REPAIR TO CRACKED GLAND SEAL IN FOSSIL PLANT

ID: 76

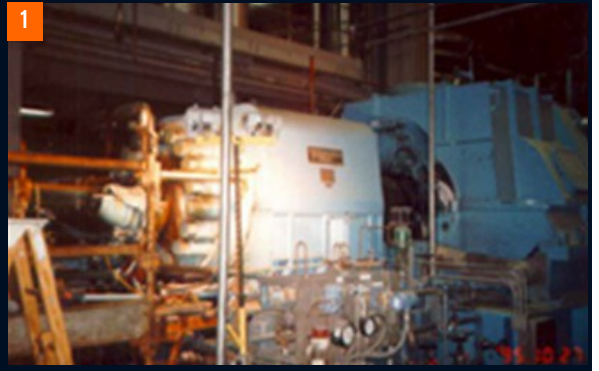
Gland seal had a cracked casing. The condensate used in the gland seal system was leaking and causing a safety problem.

1. Main Feed Pump - note rust around the gland
2. Casting on work bench prior to surface prep
3. Application of Belzona 1111
