# BELZONA SEALS LEAKING WATER TANK

ID: 7607

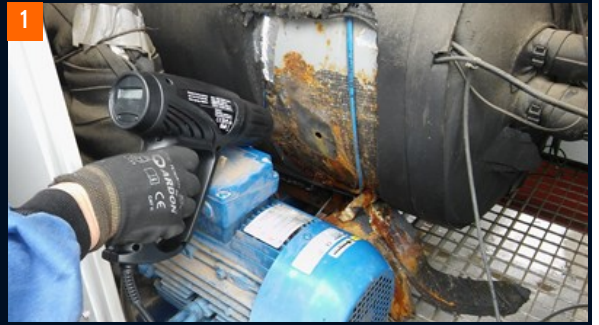
Corrosion under insulation caused by contamination from chemically treated water led to 9.5mm hole in the tank.

1. Preparing for application
2. Belzona 1111 on the steel plug
3. Plug application in the hole
4. Completed repair with Belzona 1111 incorporating Belzona 9341 applied

Application was carried out in accordance with modified Belzona System Leaflet VPF - 11. A threaded plug coated with Belzona 1111 was initially inserted into the hole before applying a patch of Belzona 1111 incorporating Belzona 9341 (Reinforcement Tape) over the top to create a more secure repair.
