# BELZONA REPAIRS JOINTS IN CONCRETE

ID: 7615

Furniture production plant, Slovakia,

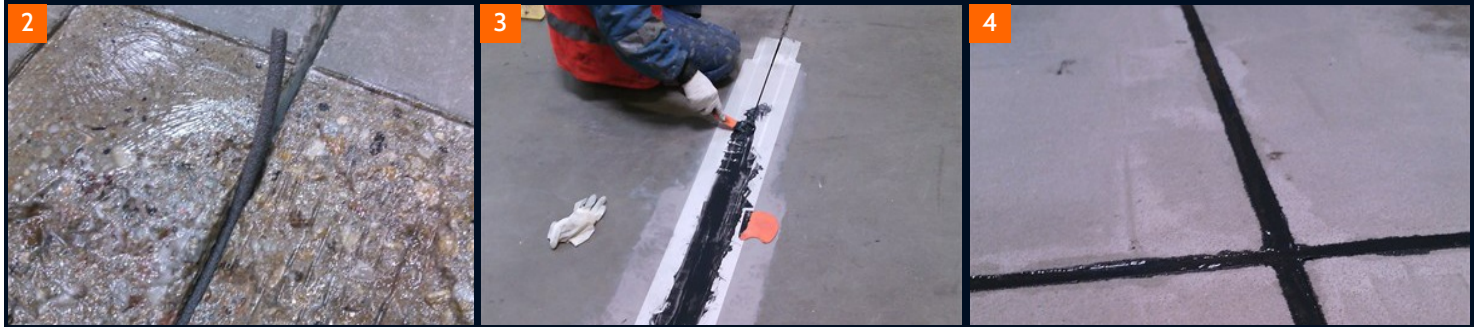
Heavy fork lift truck traffic destroyed joint nosings.

1. Damaged dilatation joint
2. Repair in progress
3. Belzona 2211 application
4. Joints ready for work

Application was carried out in accordance with Belzona System Leaflet FPA-5 and FPA-6.
