# BELZONA REPAIRS A GATE VALVE CRACK

ID: 7624

36" gate valve on a crane ship.

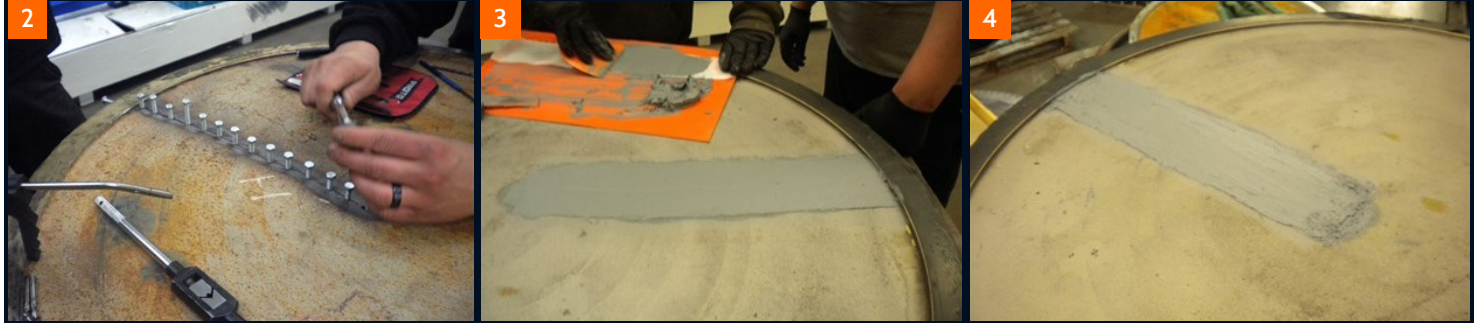
The disk of the gate valve had a large crack extending from the seat rings on the edge to the center of the disk.

1. Crack in disk of gate valve
2. Holes drilled, tapped and studs inserted. Crack terminated.
3. Reinforcement sheet incorporated to add strength.
4. Completed application.

The application was carried out in accordance with Belzona Know-How System Leaflet VPF-8. Procedure was followed out on both sides of the disk.

Due to the composition of the ductile iron welding would have been difficult. Welding also would have introduced heat stresses as well as the potential for galvanic corrosion. ABS approved this method to get the vessel back in water with minimal downtime.
