# BELZONA SUPERWRAP REPAIRS OFFSHORE PIPES

ID: 7634

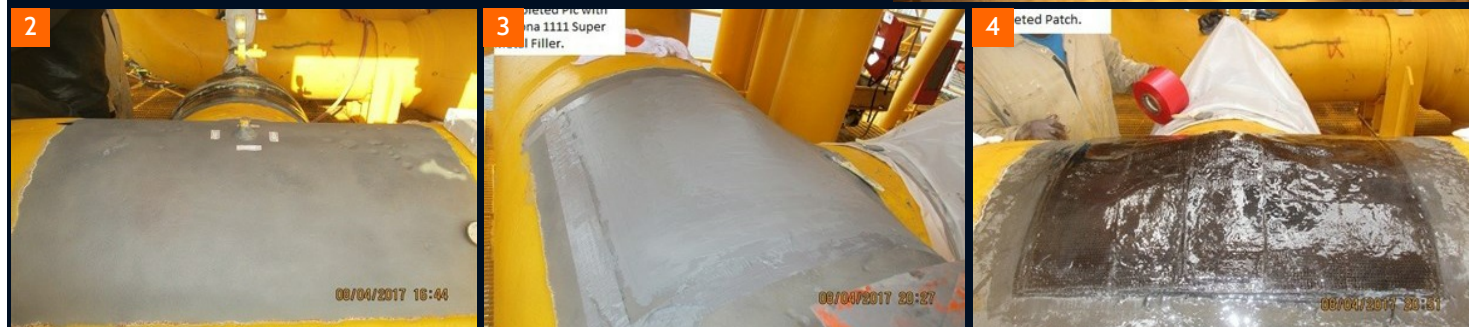
External Corrosion caused damage to the pipe, they also wanted to seal the thread-o-lets, which were no longer required. The repair had to be compliant to ASME PCC-2 and no hot work was permitted.

1. Repair location.
2. Grit blasted surface.
3. Pit filling carried out with Belzona 1111.
4. Finished SuperWrap II repair.

Application carried out in accordance with a modified version of Belzona System Leaflet VPF-11.
