# BELZONA SUPERWRAP II SEALS THROUGH CRACKS ON A 90 DEGREE FLANGE FOR A CHILLER PUMP

ID: 7654

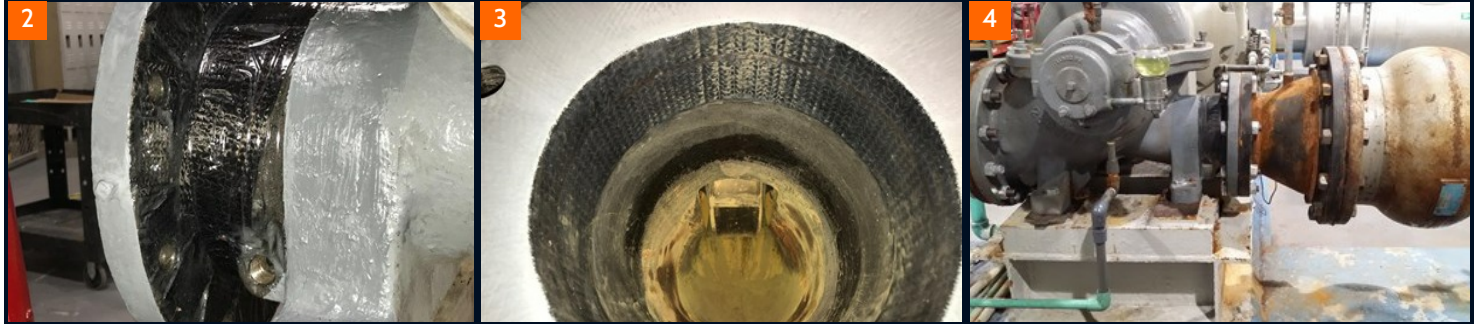
The Customer attempted to repair the cracks. However, leaks still existed after the pump was reinstalled onto the chiller return line and tested. The new solution of Belzona Superwrap II was suggested for the 90 degree flange.

The inside bend of a flange leaking return line chiller water at a theme park.

1. Customer's attempted repair.
2. Superwrap II application on the outside of the flange.
3. Superwrap II application on the inside of the flange.
4. Pump reinstalled and working after 4 months of operation nonstop and still working with no leaks.

Surface was prepared with abrasive blast clean following the Manufacturer's Instructions for Use. The ends of the through cracks were drilled and Belzona 1111 was applied into the inside of the cracks. Once Belzona 1111 set up and still within the overcoat time, 4 wraps of Belzona SuperWrap II were applied on the inside of the 90 degree bend of the flange and the outside to re-enforce it for strength. The application was carried out in accordance with a modified version of CEP-6 Belzona System Leaflet.
