# BELZONA SEALS COOLER SHELL

ID: 767

Main engine cooler

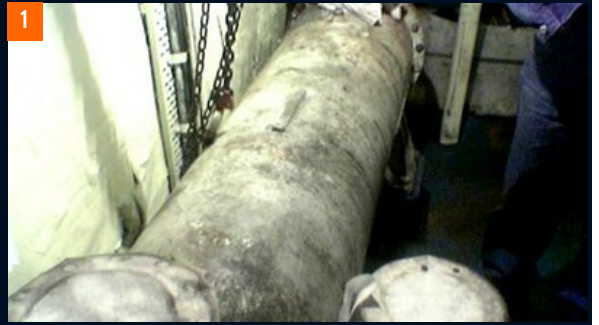
Erosion corrosion had caused hole in the shell of the cooler. Location and timescale made replacement impossible.

1. Cooler before repair
2. Application underway
3. Completing the application
4. Close up of the repair
