# TRANSFORMER DAMAGED BY A FORKLIFT REPAIRED WITH BELZONA

ID: 7672

Electrical transformer cooling fin damaged by a forklift at a local recycling center.

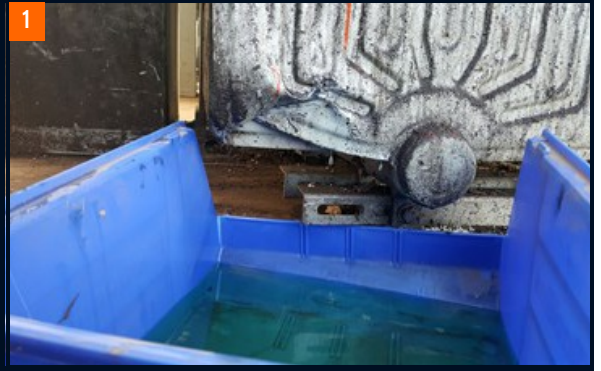
Forklift hit the cooling fins on an electrical transformer causing a serious oil leak.

1. Note the oil dripping.
2. Damage is severe, bending the cooling fin.
3. & 4. Belzona 1212 applied, repair complete.
