# BELZONA SUPERWRAP II SUCCESSFULLY TACKLES A LIVE LEAK REPAIR

ID: 7684

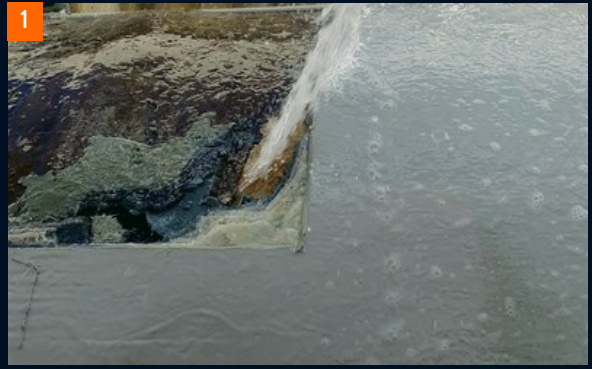
The pipe burst after an outage causing the plant to shutdown.

Fiberglass 36" pipe of a cooling tower.

1. Showing damage. 2. Surface preparation. 3. Plate bonding with Belzona 1212. 4. Superwrap II System installed.
