# BELZONA SUPPORTS EFFLUENT TANK

ID: 7699

Damaged concrete supports of effluent water vessel

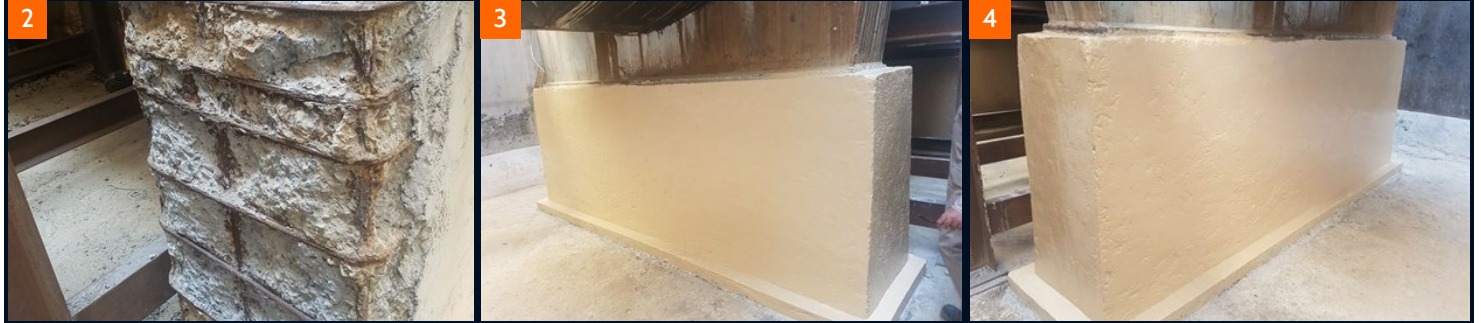
Water ingress and weathering had caused corrosion of the reinforcement bar, leading to cracking and spalling of the concrete supports.

1. Cracked and Spalling Concrete
2. Damaged and loosely adhered concrete removed
3. Concrete supports repaired and coated
4. Concrete supports repaired and coated

Damaged and loose concrete was removed before the surface was abraded using mechanical tools to clean and roughen the surface, and remove corrosion from the reinforcement bar. Compressed air was then used to remove dust. The surface was primed with Belzona 4911, and Belzona 4141 used to rebuild the surface to the original dimensions. For additional protection from weathering and potential spillage from the tank, 2 coats of Belzona 5811 were added to protect the vessel supports.
