# BELZONA REPAIRS LEAKING CPVC COOLING WATER LINES

ID: 7721

Cooling water line for biomass power generation turbine.

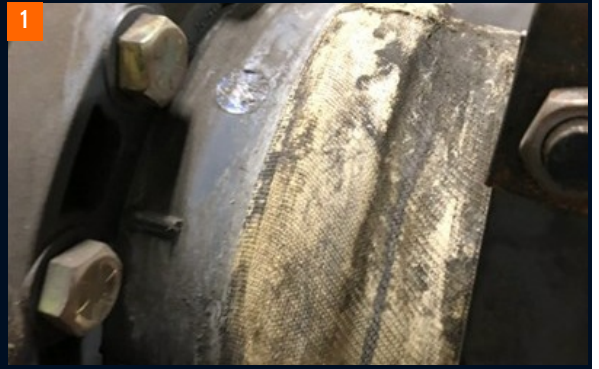
The customer was experiencing significant water leaks from a 250mm (10 inch) cooling water line, through an existing non-Belzona wrap repair. The leaks were occurring at the fitted flanges of two separate lines. Due to the severity of the leak, the biomass generation turbine was taken out of service until a Belzona repair could be completed.

1. Water leaking through existing wrap repair.
2. Cleaning CPVC with Belzona 9111.
3. Completed Belzona 1161 repair.
4. Completed Belzona 1161 repair to a parallel line.
