# BELZONA TOP UP AFTER 3 YEARS SERVICE

ID: 7743

Condensate extractor pumps carrying water contaminated with H<sub>2</sub>S and SO<sub>2</sub> at Geothermal Power Plant.

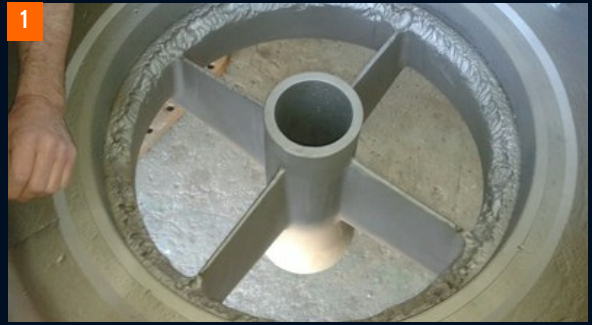
Impingement erosion coupled with corrosion from the contaminated water had caused significant metal loss to various areas of the pump housing. Damage was most noticeable around the flow straighteners, where turbulent flow had increased the rate of erosion.

1. Erosion / Corrosion damage
2. Crack ends drill tapped and terminated by metal stitching
3. Repair and coating application complete
4. Re-coated after 3 years in service
