# BELZONA REPAIRS A PAPER MILL PUMP

ID: 7757

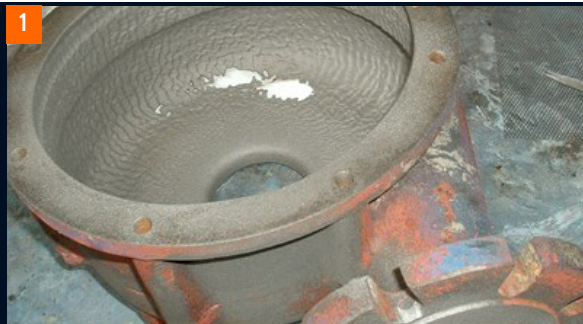
A paper pulp pump was severely damaged by abrasion because of the presence of paper clips and staples in the pulp it transports. The existing coating could not withstand this abrasive paste which caused impingement.

Pump casing severely damaged by abrasion.

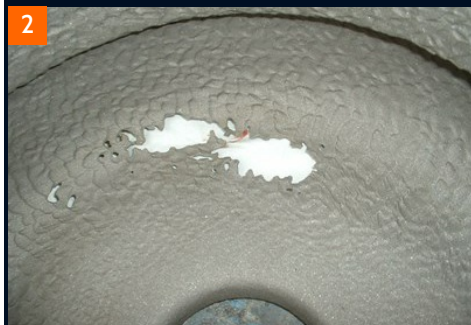
Zoom on the hole resulted from the circulation of abrasive fluid.
