# BELZONA ELASTOMERS REBUILD FLANGE GASKET ON A CRUISE SHIP

ID: 7778

Cruise ship flange gasket rebuilding.

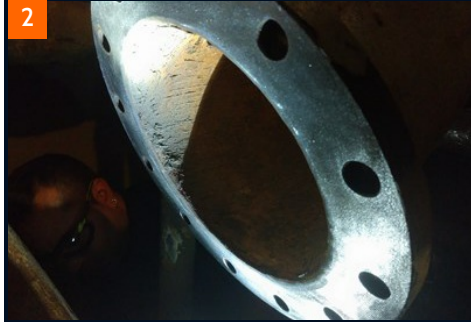
Flowing seawater had degraded the original gaskets on several flanges of this 963 foot cruise ship. Further damage was caused by the removal of adjacent valves for service.

Damaged gasket on flange.

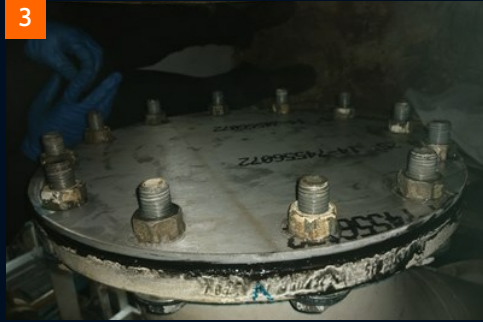
Surface prepared and ready for Belzona Elastomer rebuild.

Application was completed with a modified version of Belzona System Leaflet GSS-1 for creating gaskets. Damaged gasket material was removed. Steel substrate was cleaned and abraded with a grinder and MBX Bristle Blaster. The surface of the flange was then treated with a thin coat of Belzona 2911. Once the conditioner cured the flange face gasket was built up with Belzona 2121. A custom former or Blank that had been coated with a release agent was then lightly bolted onto the flange face to reform the gasket. Once Belzona 2121 had cured the former was removed to reveal the new gasket. Any excess material was then cut away with a razor blade.

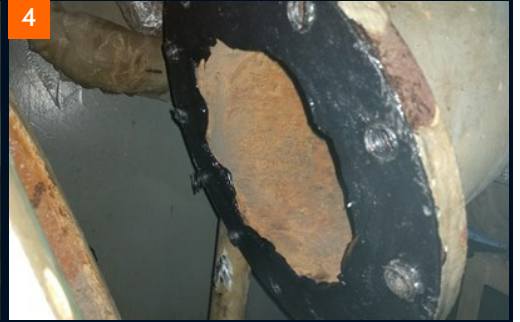
Former applied, Belzona 2121 curing.
