# BELZONA SEALS LEAKING WELDS IN FUEL TANK

ID: 779

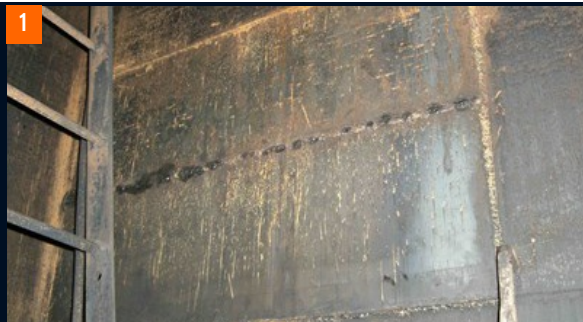
Heated Diesel Tank (steam heated to 160°F). Welded doubler plates were found to be perforated and leaking post dry dock.

1. Previous dry dock weld of doubler plates
2. Perforated welds
3. Roughened and degreased
4. Welds sealed allowing ship to sail on time
