# COOLING WATER SPOOLS AFTER 5 YEARS IN SERVICE WITH BELZONA

ID: 7793

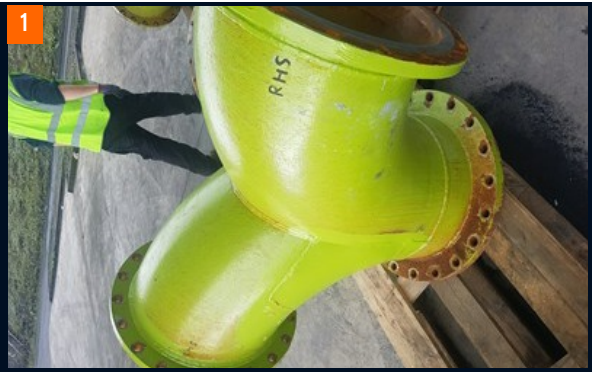
1. Y- piece
2. Condition of Belzona 1321
3. Elbow
4. Condition of Belzona 1321
