# BELZONA 1311 SALVAGED A CRACKED LINING ON A VALVE

ID: 7794

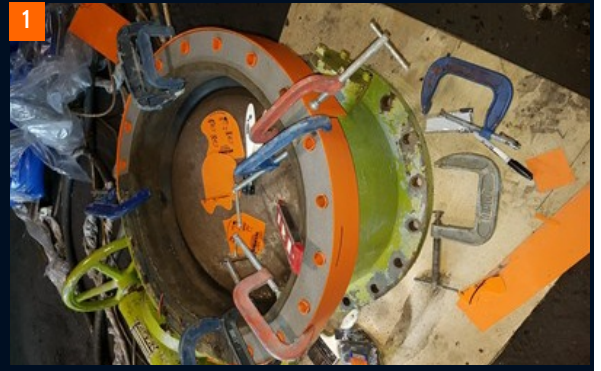
The ebonite lining on a valve from the auxillary cooling water system had cracked and failed around the valve flange

The damaged ebonite liner was removed. The exposed steel was washed and grit blasted. Using a modified version of Belzona Know-How System leaflet GSS-10, formers were made from Belzona working surfaces and clamped into position. Belzona 1311 was applied and following curing the formers were removed.

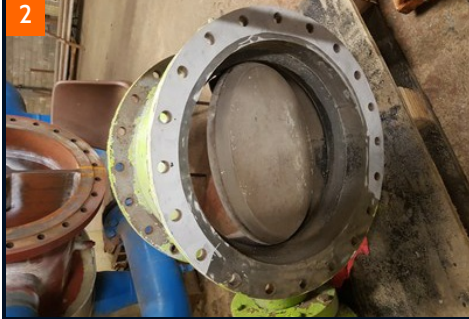
Substrate blasted and formers in position.

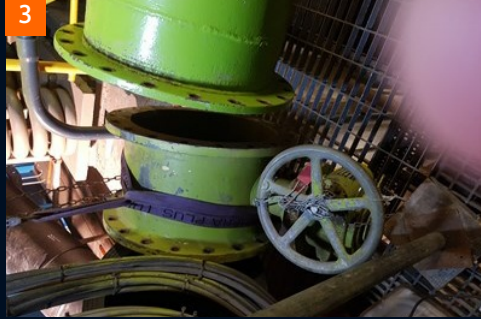
Repaired vlave ready to be installed.

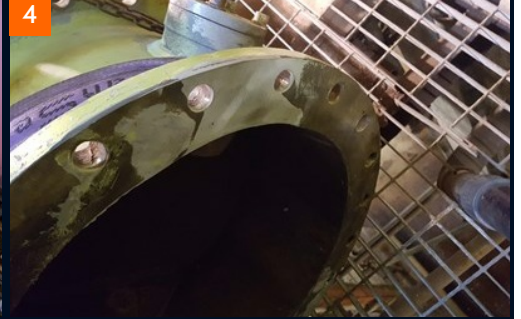
Valve being installed.
